Name of Dam: Gaines Mill Dam

Inventory Number: VA 08506 ✓

# PHASE I INSPECTION REPORT

## NATIONAL DAM SAFETY PROGRAM

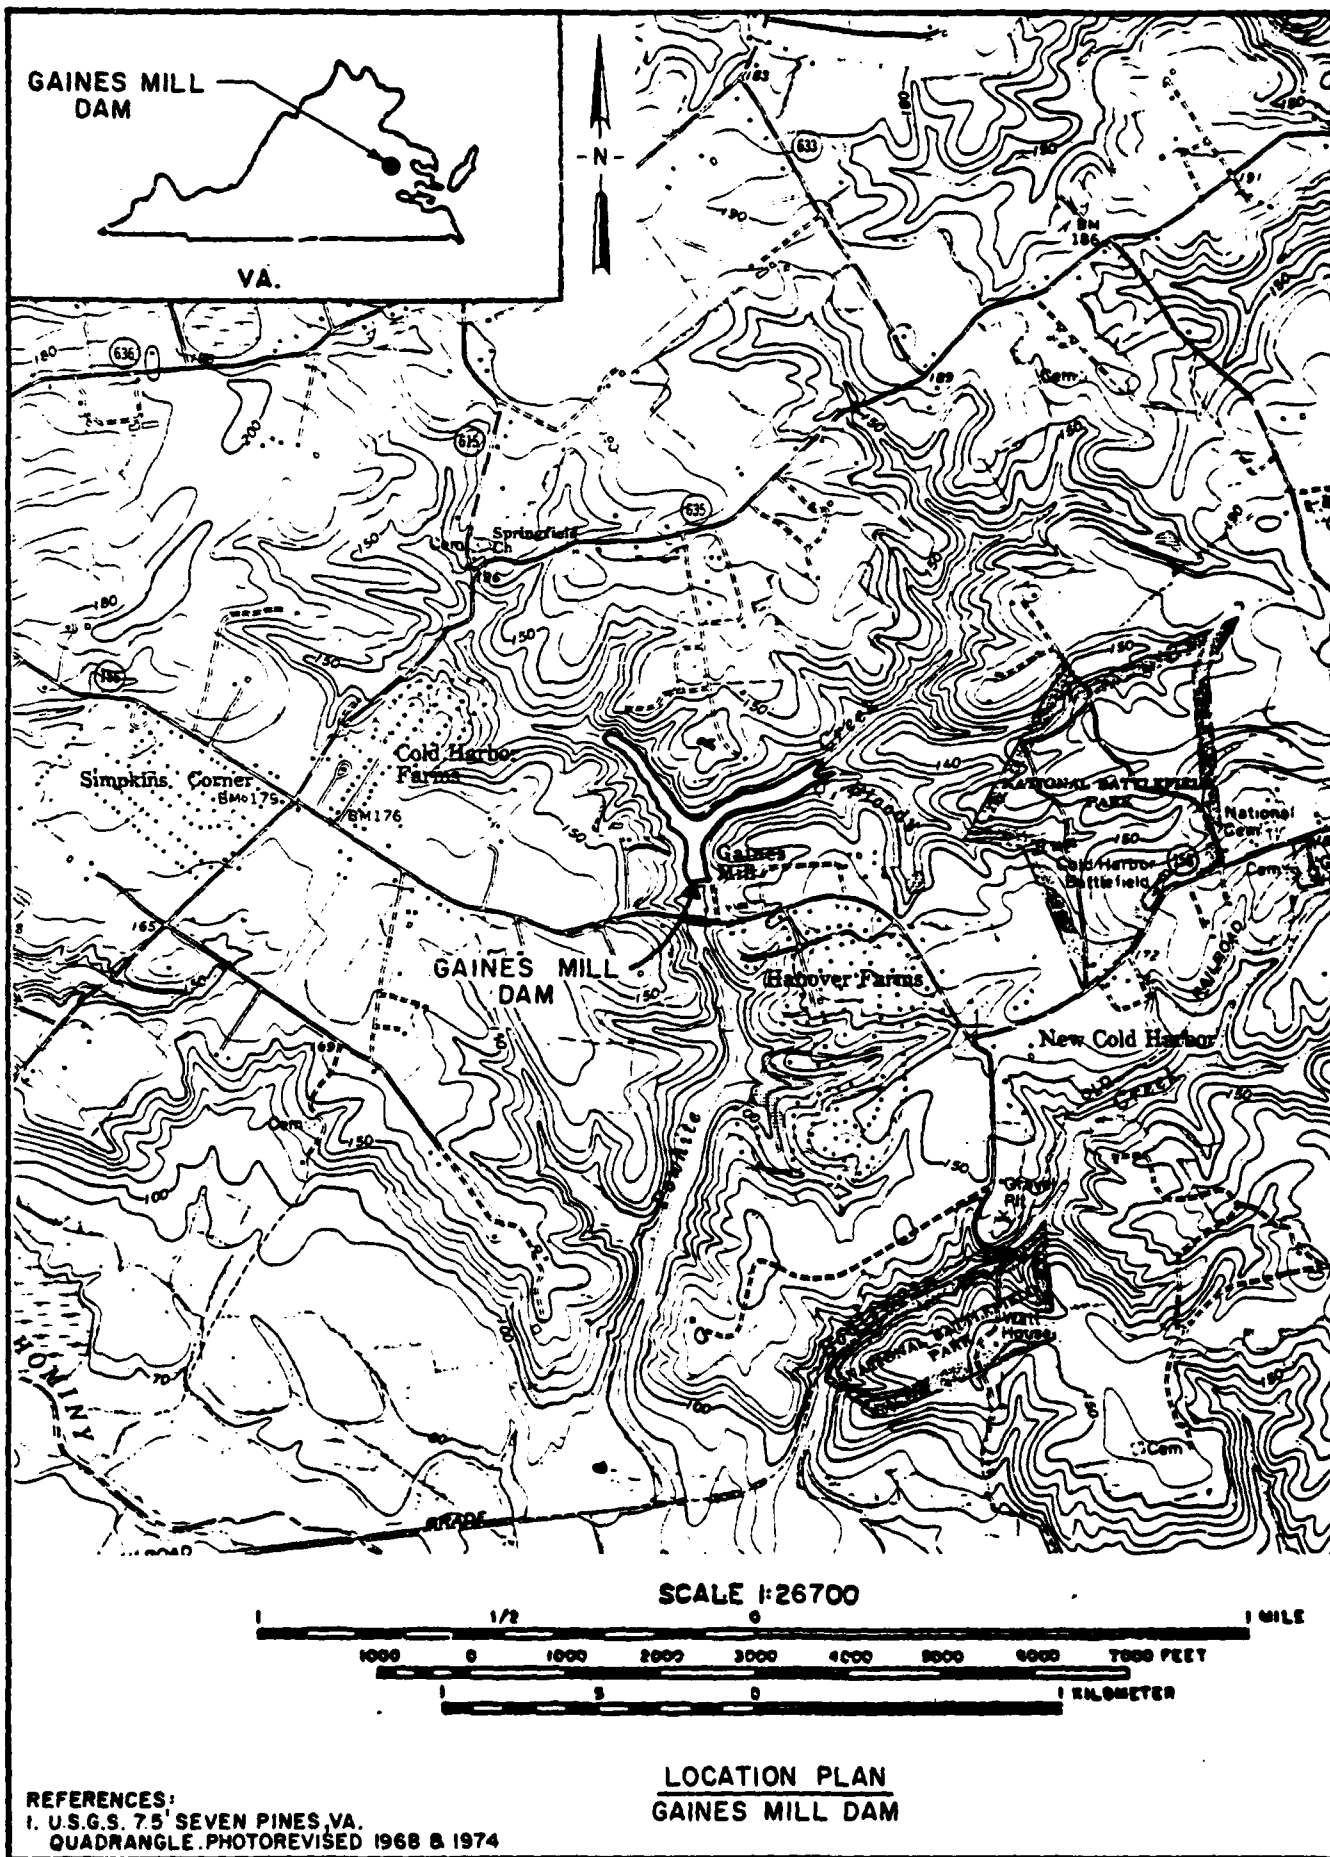
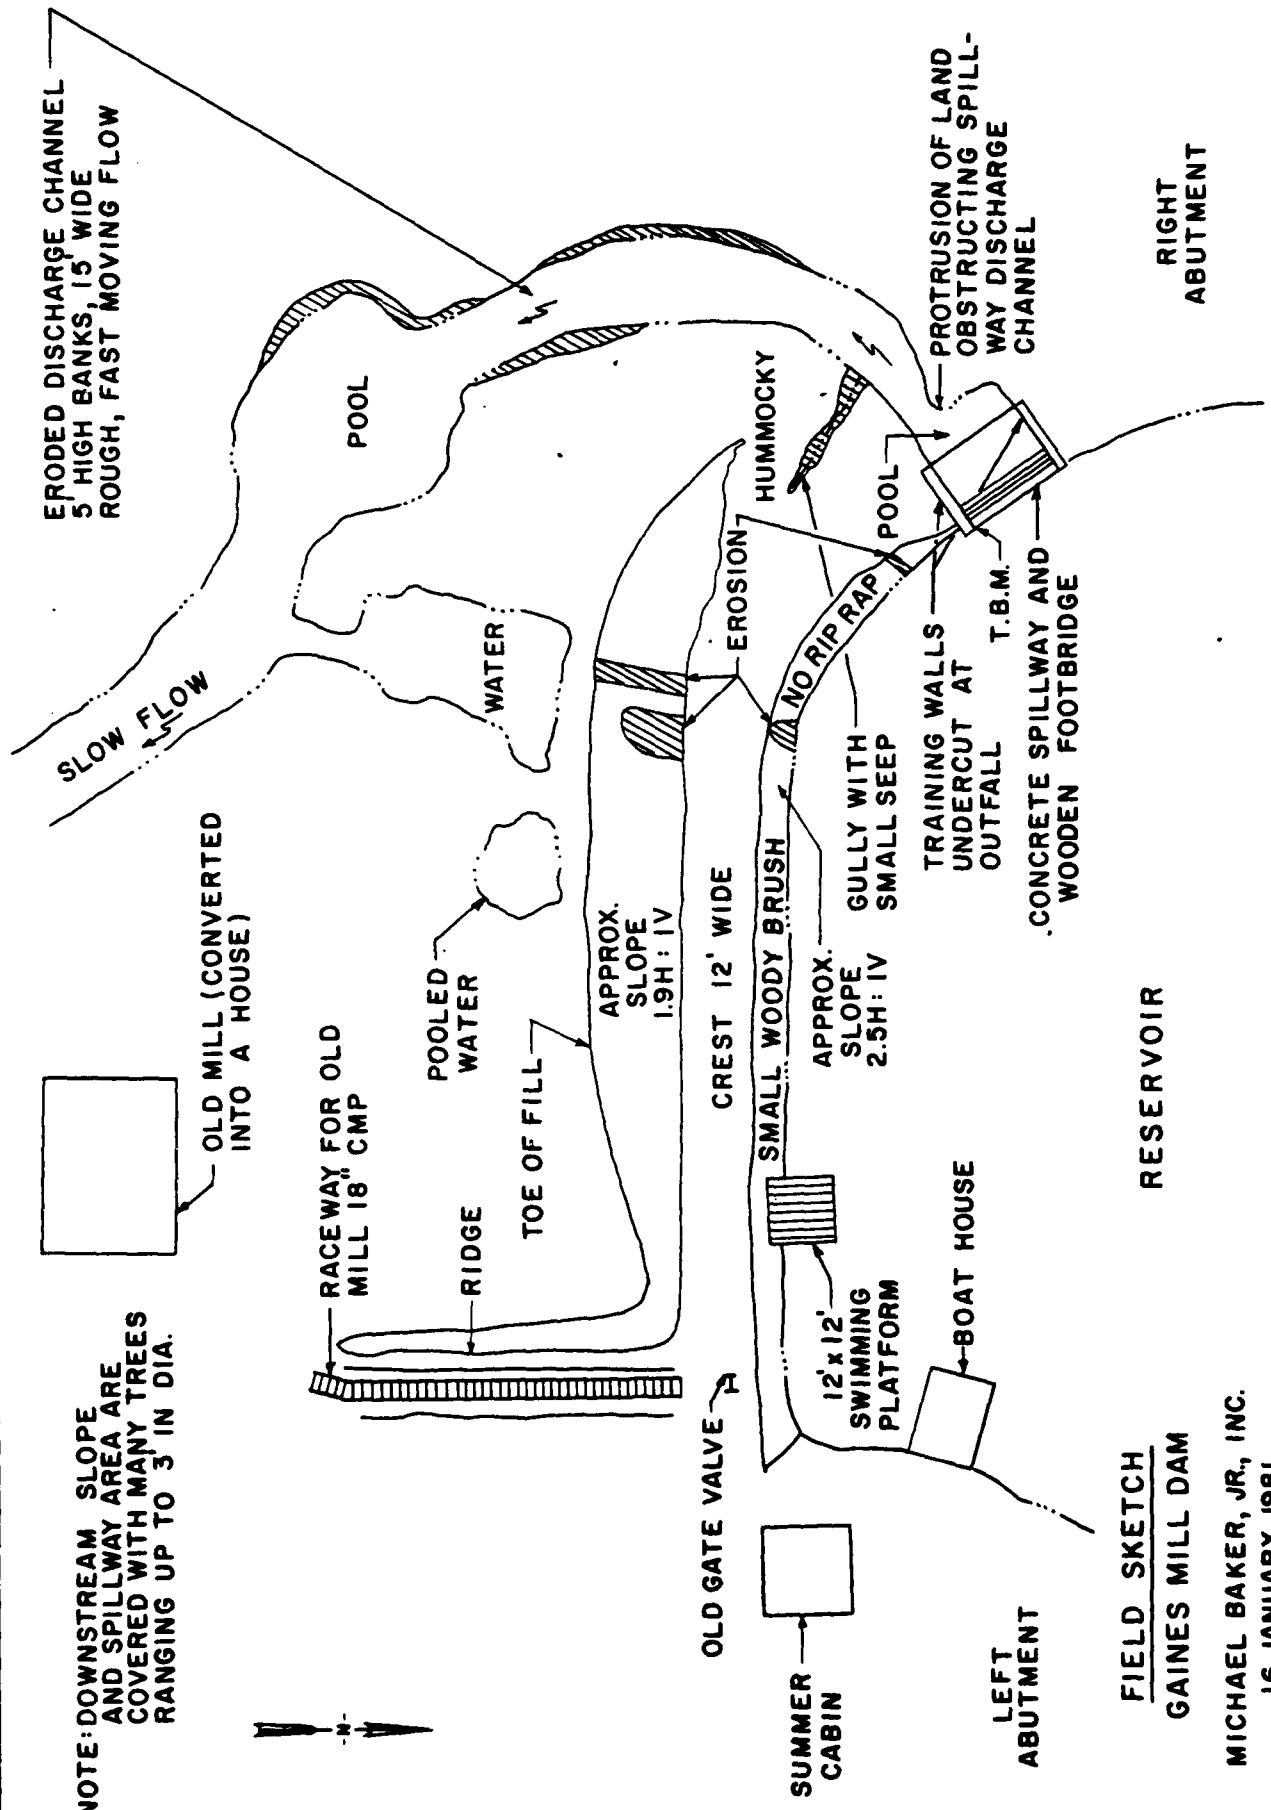
FIELD SKETCH  
GAINES MILL DAM

NOTE: DOWNSTREAM SLOPE AND SPILLWAY AREA ARE COVERED WITH MANY TREES RANGING UP TO 3 IN DIA.

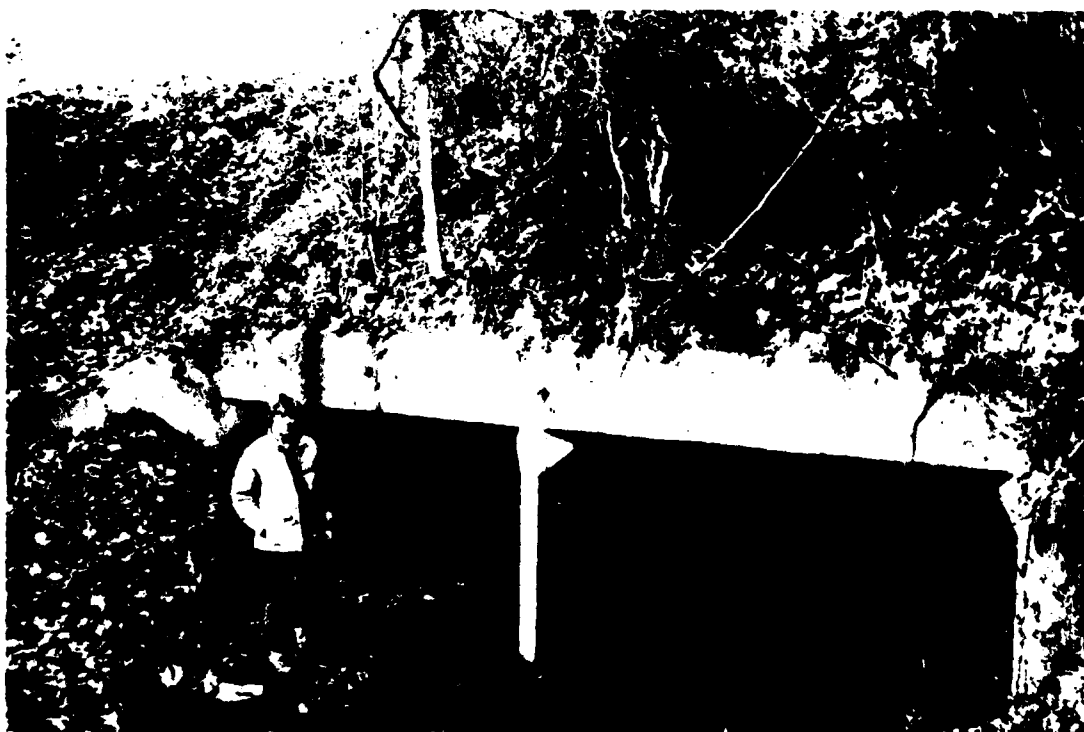
**PHOTO 4. Culverts Under VA Route 186**
